1 Example Road, Exampleton,  
England, EX1 1PL

## This report contains

## Property Information

A terraced three bedroom property with an attached double garage. The property benefits from an En-suite bathroom and great sized garden.

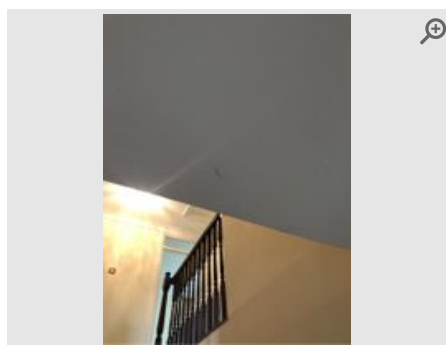
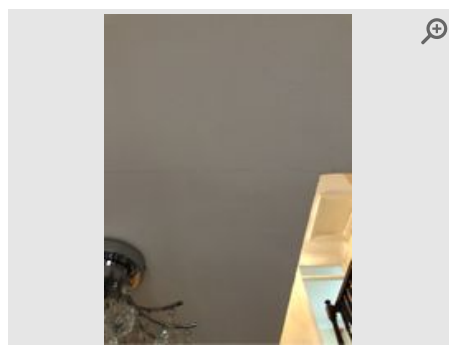
## Ceiling

| 1 Entrance/Hallway | | | | |
|---|---|---|---|---|
| <b>Ceiling</b><br>1.4 | Plastered/Painted white. White coving. Hairline crack present. Marked Free of marks, mould and cobwebs. | ● Good | ● Good | 2 photos |

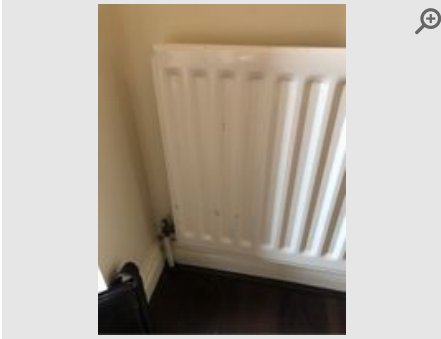
## Radiator

| 1 Entrance/Hallway | | | | |
|---|---|---|---|---|
| <b>Radiator</b><br>1.9 | White panelled. Valve cap missing (left). Valve cap missing (right). Scuffed Wall mounted radiator(s) free of marks and scuffs. All valve caps present and intact. | ● Good | ● Good | 1 photo |

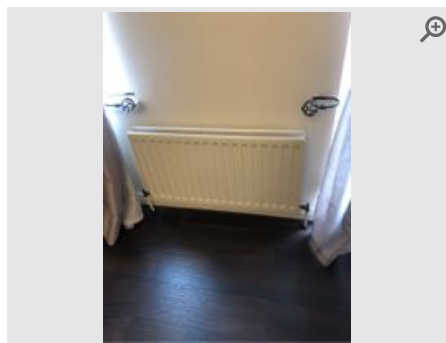
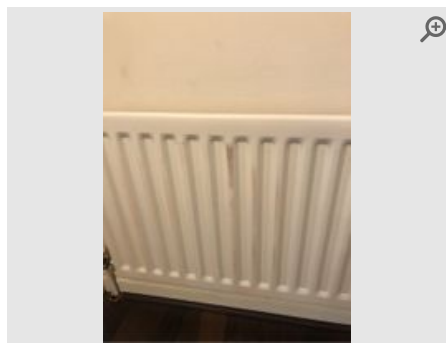
| Reference | 2.8.1 |

| Item | Description | Condition | Cleanliness | Photos |
|---|---|---|---|---|
| <b>Radiator</b><br>2.8 | White panelled. 2 in total. Valve cap missing (left). Valve cap missing (right).<br>Discoloured<br>Wall mounted radiator(s) free of marks and scuffs. All valve caps present and intact. | ● Good | ● Good | 📷 2 photos |

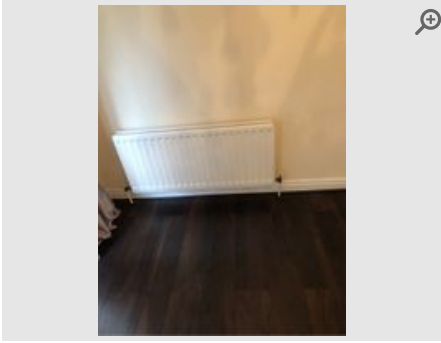
### Radiator

| Item | Description | Condition | Cleanliness | Photos |
|---|---|---|---|---|
| <b>Radiator</b><br>3.8 | Valve cap missing (right)<br>Wall mounted radiator(s) free of marks and scuffs. All valve caps present and intact. | ● Good | ● Good | 📷 1 photo |

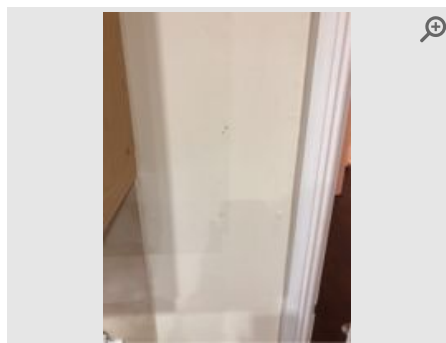
| Reference | <b>4.6.1</b> |

| Item | Description | Condition | Cleanliness | Photos |
|---|---|---|---|---|
| <b>Walls</b><br>4.6 | Plastered & painted cream. Tiled (around worktops). Raw plug/nail holes present<br>Free of marks stains and scuffs. No picture hooks, raw plug or filled holes present. | ● Good | ● Good | 📷 1 photo |

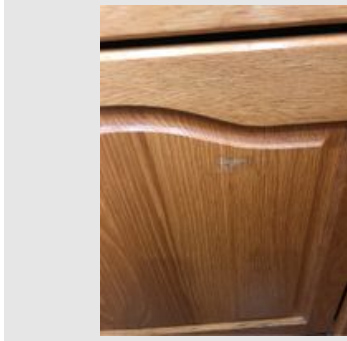
| Reference | <b>4.11.2</b> |

| Item | Description | Condition | Cleanliness | Photos |
|---|---|---|---|---|
| <b>Kitchen Cupboards/Units</b><br>4.11 | Solid wood. Laminate peeling (casing). Doors marked & scratched<br>All handles and hinges intact. Free of items inside. Free of stains underneath sink.<br>Free of grease and food residue inside. | ● Good | ● Good | 📷 3 photos |

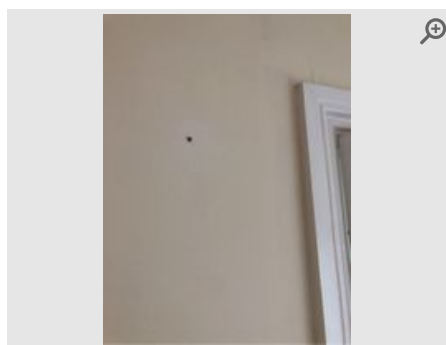
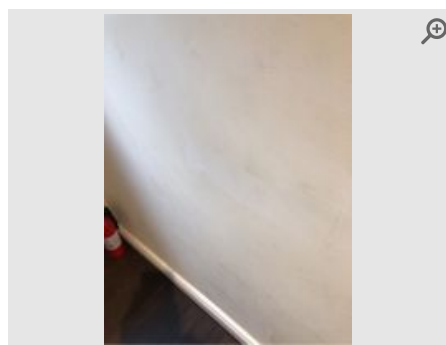
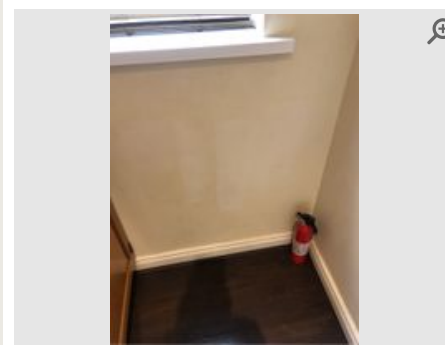
## Walls

| Item | Description | Condition | Cleanliness | Photos |
|---|---|---|---|---|
| <b>Walls</b><br>5.6 | Plastered & painted cream. Tiled (around worktops). Raw plug/nail holes present.<br>Discoloured paintwork<br>Free of marks stains and scuffs. No picture hooks, raw plug or filled holes present. | ● Good | ● Good | 📷 3 photos |

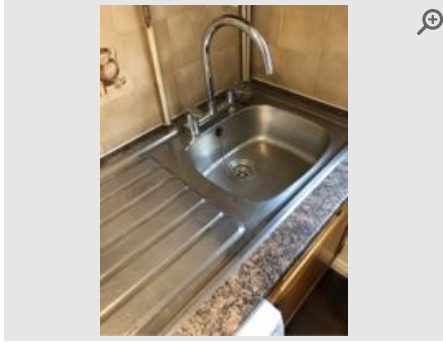
| Reference | <b>5.11.1</b> |

| Item | Description | Condition | Cleanliness | Photos |
|---|---|---|---|---|
| <b>Kitchen Sink</b><br>5.11 | Single bowl. Stainless steel. Mixer tap. Chrome waste. Plug not present<br>Free of scratches and cracks. No food residue or grease present. Plug present. | ● Good | ● Good | 📷 1 photo |

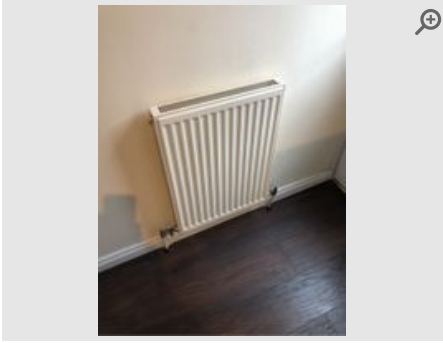
## Radiator

| Item | Description | Condition | Cleanliness | Photos |
|---|---|---|---|---|
| <b>Radiator</b><br>5.19 | White panelled. Valve cap missing (left). Valve cap missing (right) | ● Good | ● Good | 📷 1 photo |

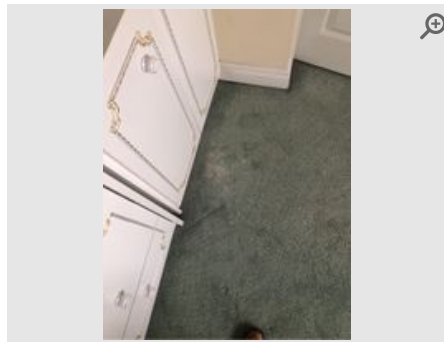
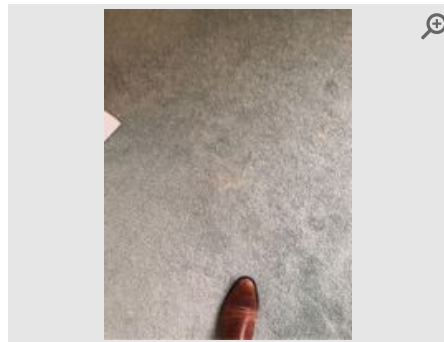
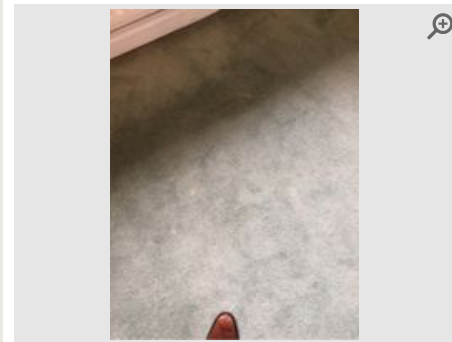
## Floor

| Item | Description | Condition | Cleanliness | Photos |
|---|---|---|---|---|
| <b>Floor</b><br>11.10 | Carpeted. Discoloured patches. Green<br>Some staining | ● Fair | ● Fair | 📷 3 photos |
