1 Example Road, Exampleton,  
England, EX1 1PL

## This report contains

## Property Information

A terraced three bedroom property with an attached double garage. The property benefits from an En-suite bathroom and great sized garden.

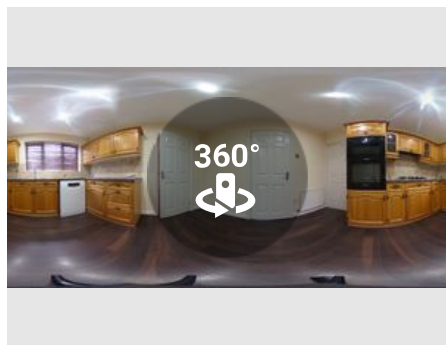
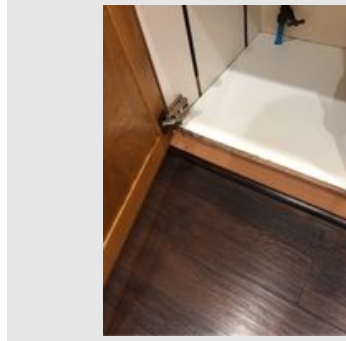
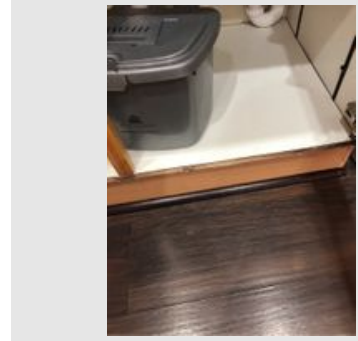
| Reference | <b>4.11.1</b> |

| Item | Description | Condition | Cleanliness | Photos |
|---|---|---|---|---|
| <b>Kitchen Cupboards/Units</b><br>4.11 | Solid wood. Laminate peeling (casing). Doors marked & scratched<br>All handles and hinges intact. Free of items inside. Free of stains underneath sink.<br>Free of grease and food residue inside. | ● Good | ● Good | 📷 3 photos |

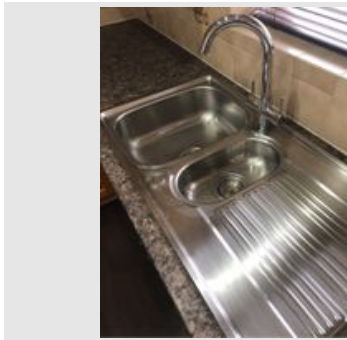
| Reference | <b>4.14.1</b> |

| Item | Description | Condition | Cleanliness | Photos |
|---|---|---|---|---|
| <b>Kitchen Sink</b><br>4.14 | Stainless steel. Mixer tap. Chrome plug. Chrome waste<br>Free of scratches and cracks. No food residue or grease present. Plug present. | ● Good | ● Good | 📷 1 photo |

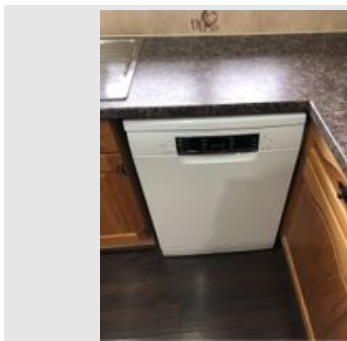
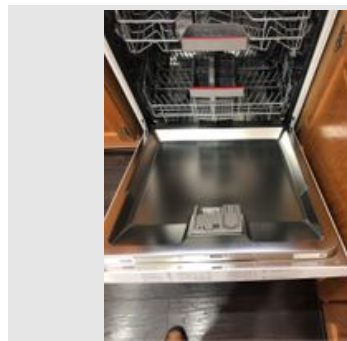
| Reference | <b>4.21.1</b> |

| Item | Description | Condition | Cleanliness | Photos |
|---|---|---|---|---|
| Dishwasher<br>4.21 | Free standing. Bosch<br>Free of food residue in filter. Rack hinges functioning smoothly. Machine door opens smoothly. | ● Good | ● Good | 📷 2 photos |

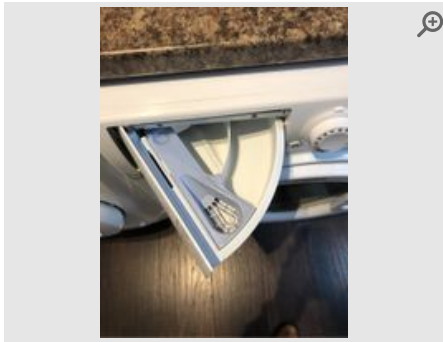
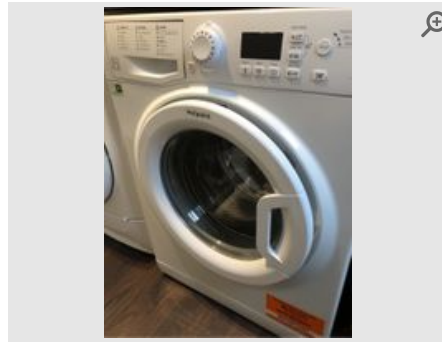
| Reference | <b>5.13.1</b> |

| Item | Description | Condition | Cleanliness | Photos |
|---|---|---|---|---|
| <b>Washing Machine</b><br>5.13 | Hotpoint<br>Seal is clean and intact. No signs of damage to drum inside. Door hinge is functioning smoothly. Detergent drawer is clean. | ● Good | ● Good | 📷 2 photos |

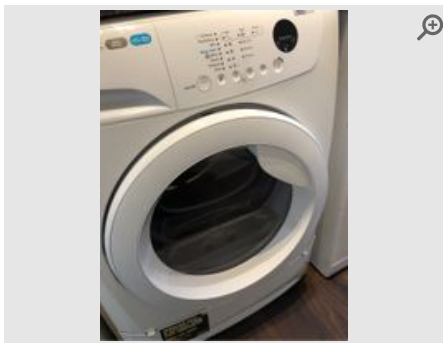
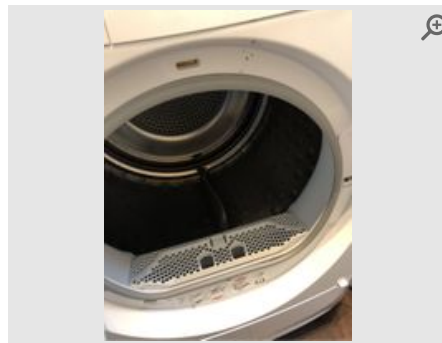
| Reference | <b>5.14.1</b> |

| Item | Description | Condition | Cleanliness | Photos |
|---|---|---|---|---|
| <b>Tumble Dryer</b><br>5.14 | Zanussi<br>Seal is clean and intact. No signs of damage to drum inside. Door hinge is functioning smoothly. | ● Good | ● Good | 📷 2 photos |

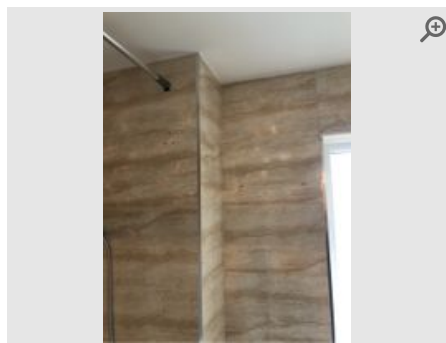
| Reference | <b>13.6.1</b> |

| Item | Description | Condition | Cleanliness | Photos |
|---|---|---|---|---|
| <b>Walls</b><br>13.6 | Tiled. Raw plug/nail holes present. Free of dirt/dust. Beige<br>Free of marks stains and scuffs. No picture hooks, raw plug or filled holes present. | ● Good | ● Good | 📷 1 photo |

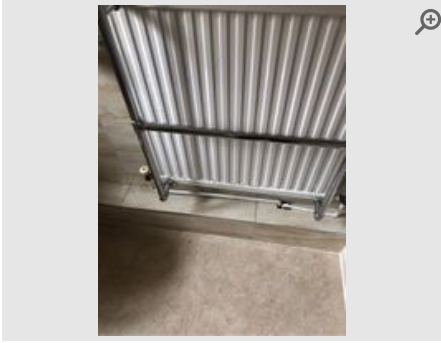
| Reference | 13.8.1 |

| Item | Description | Condition | Cleanliness | Photos |
|---|---|---|---|---|
| <b>Radiator</b><br>13.8 | White panelled. Chrome columns. Valve cap missing (right). Signs of rust | ● Fair | ● Fair | 📷 1 photo |

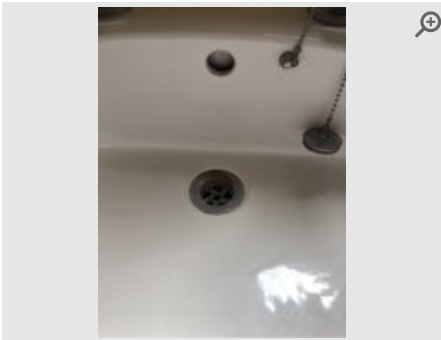
| Item | Description | Condition | Cleanliness | Photos |
|---|---|---|---|---|
| <b>Sink/Basin</b><br>13.13 | Pedestal porcelain. Separate taps. Chrome taps. Plug & chain<br>Basin intact and free of cracks/chips. No gaps to sealant around edges. Clean and free of hairs. Limescale present to waste and plug | ● Good | ● Good | 📷 1 photo |

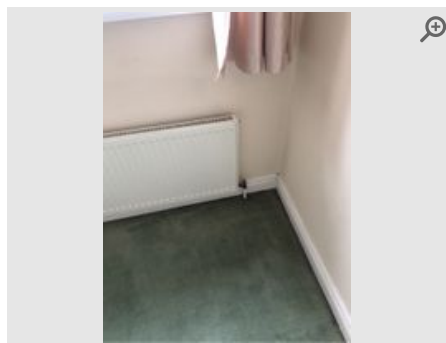
| Reference | 14.8.1 |

| Item | Description | Condition | Cleanliness | Photos |
|---|---|---|---|---|
| <b>Radiator</b><br>14.8 | Wall mounted radiator(s) free of dust and dirt, one cap on right hand side is missing | ● Fair | ● Fair | 📷 1 photo |

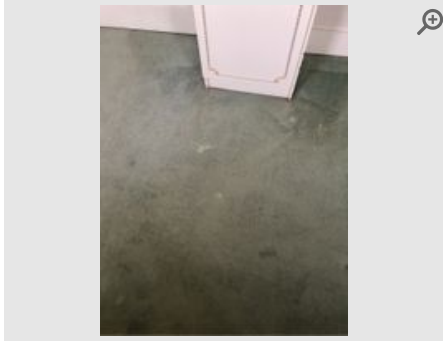
| Item | Description | Condition | Cleanliness | Photos |
|---|---|---|---|---|
| <b>Floor</b><br>14.10 | Carpeted. Discoloured patches. Green<br>Free of stains, marks and scratches. | ● Good | ● Good | 📷 1 photo |
